RASSI: A Systematic Approach for On-site Crash Investigations and In-depth Accident Data Collection in India

2013-26-XXXX
Published on
9th -12th January
2013, SIAT, India

Jeya Padmanaban
Ravishankar Rajaraman
Swastik Narayan
C T Arjun
Ajay Patel
Ahamedali M. Hassan
JP Research India Pvt. Ltd.

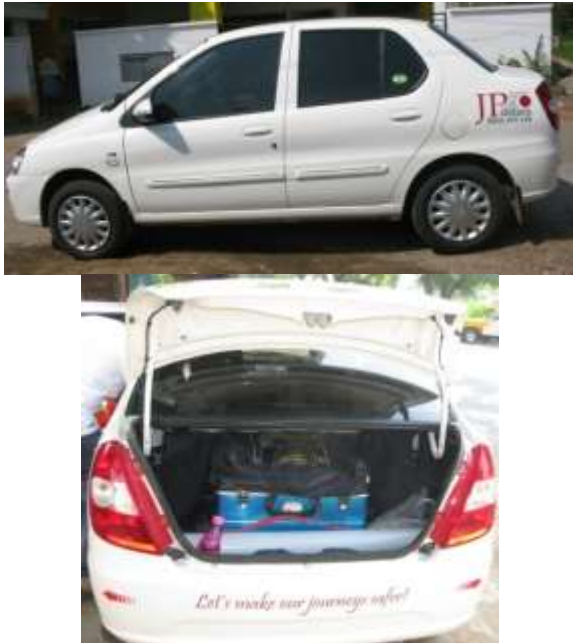
CRASH INVESTIGATION - As soon as a notification is received about an accident in the study area from the above sources, a team of researchers immediately travel to the crash spot in an accident research vehicle, shown in [Figure 2](#), which also houses the investigation kit and other necessary equipment needed by the researchers.

Figure 2. Accident research vehicle used by the researchers.

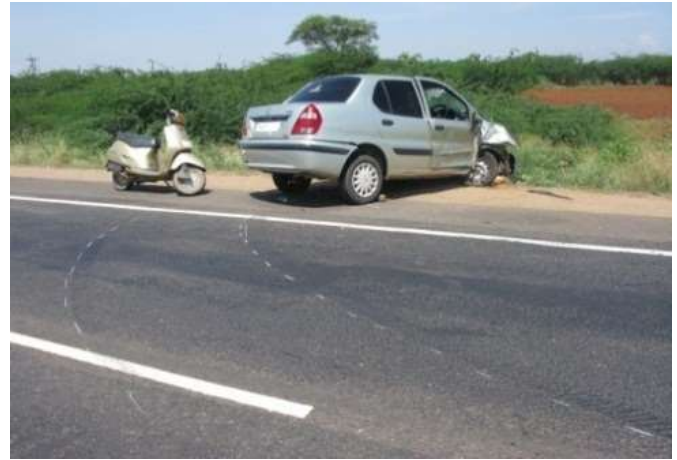
Scene examination - It involves identifying the accident spot, the final rest positions of the vehicles (when vehicles are not available on the spot), recording of GPS co-ordinates, weather conditions etc. Victim or eyewitness statements are also taken and recorded, for which evidences are sought on the scene in order to check their reliability. The evidence is marked using chalk or paint, and scene photographs are taken by the researchers in the direction of travel of the involved vehicle(s). Scene pictures also include pictures of the skid marks, debris, point of impact, objects struck, blood marks, fluid spills, etc. An example is shown in [Figure 3](#).

Figure 3. Scene picture of evidence taken at the crash spot.

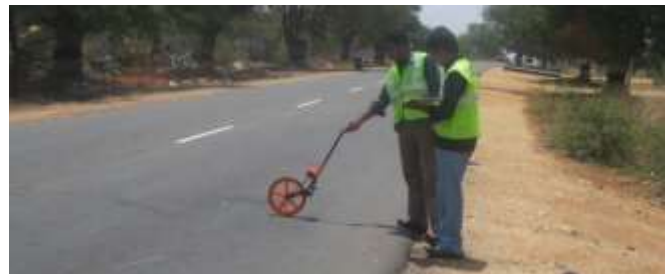
The crash spot is measured using a rodometer (shown in [Figure 4](#)) along with the final rest positions, tire marks, lane widths and markings, object positions, point of impact etc.

Figure 4. Researchers measuring the scene using a rodometer.

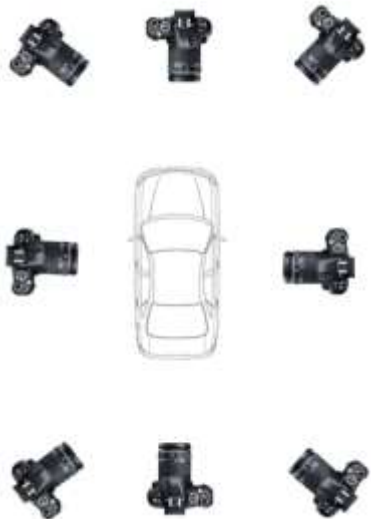
Exterior examination - This involves examining the exterior parts of the accident vehicle to check for direct and indirect damages on the vehicle. Direct damages are caused due to the direct contact with other vehicle or object, and are mostly characterized by paint transfers, shape imprints on the body of vehicle. Indirect damages are induced by the direct damage, and are characterized by buckling or soft wavy damage patterns on the body. Photographs of the vehicle are then taken from eight angles (Figure 6a) and also with doors open (Figure 6b), and then of the damages and other contact points, if any, on the exterior of vehicle.

Figure 6a. Photographs of the accident vehicle are taken from eight angles.

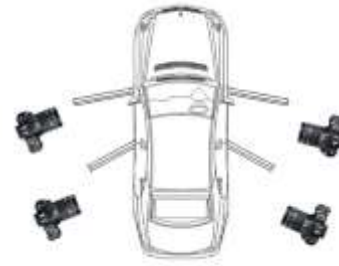
Figure 6b. Photographs of the accident vehicle showing the interiors (with doors open).

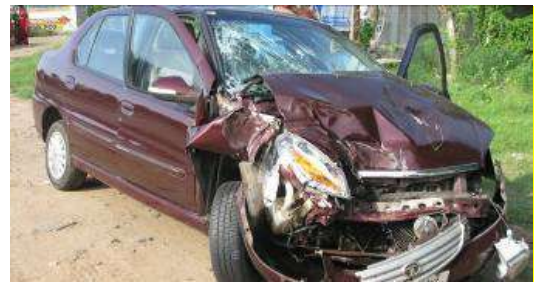
Direct damage measurements are taken and used to code the Collision Deformation Classification (or CDC) [8] for every crash event on a vehicle. CDC is a 7-character alpha-numeric code that describes the direct damage to a vehicle, and provides engineers, crash investigators and statisticians with a quick snapshot of a crash's configuration and severity. An example is shown in Figure 7 where CDC is coded for the passenger car shown in the picture. In case of trucks, Truck Deformation Classification (TDC) [9] is applied, while for buses and motorized two wheelers only the first three characters of the CDC are coded.

CDC – 01 F Z E W 3

Figure 7. An example case where the CDC has been coded for a car which rear ended a truck.

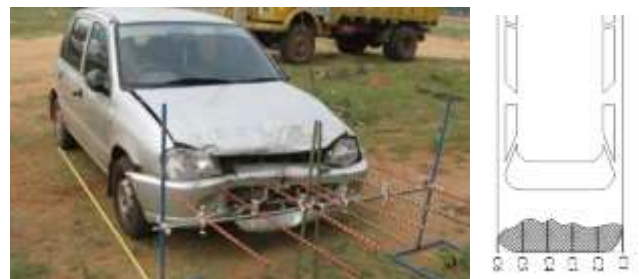
Researchers also measure the crush profile when the crush is on the stiff member of the vehicle. The crush is measured at six equidistant points along the direct and indirect damage on the stiff member (Figure 8). This crush profile along with the stiffness values of a vehicle can help in deriving the Equivalent Barrier Speed (EBS) of the crash vehicle.

Figure 8. Crush profile being measured on a passenger car using crush jig.

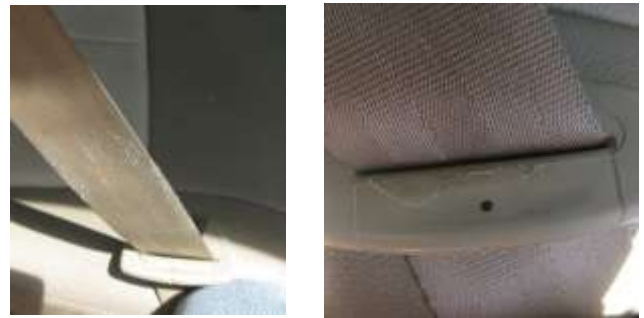
Seat belt usage by occupants is also checked for during interior examination. The seat belts are checked for any marks on the webbing (due to the sudden stretching) if used. There may also be melting of the seat belt buckle ([Figure 10](#)) which indicates seat belt use by the occupant in that seat. Seat belts are also checked to see if the pre-tensioners (if available) have fired during the crash.

Figure 10. Seat belt webbing found stretched (left), and melting of the seat belt buckle seen due to usage by the occupant (right).

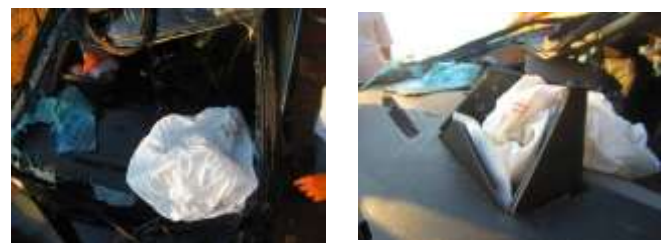
Deployment of air bags (if available) is recorded, and tear points are observed to see if the airbag compartment has torn along the tear points ([Figure 11](#)). Any damage to the airbags are also recorded and photographed.

Figure 11. Deployment of airbags (left); Tear points being inspected (right).

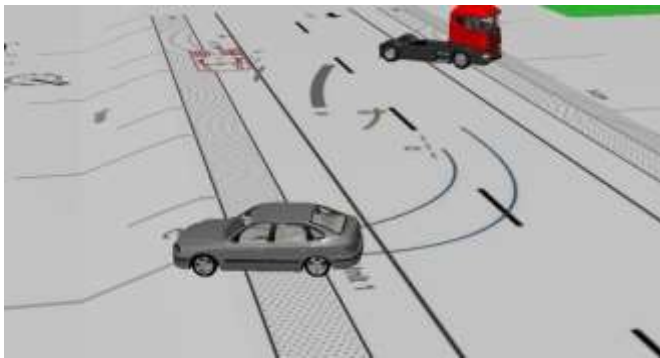
1. A PC-Crash report summarizing the inputs and outputs.
2. A 3D simulation of the accident as shown in [Figure 12](#).

Figure 12. An example of a 3D Simulation in PC-Crash using the scene diagram shown in [Figure 5](#).

The report is analyzed and the data such as Delta V, EES, and velocities before and at the time of impact are coded in the RASSI database.

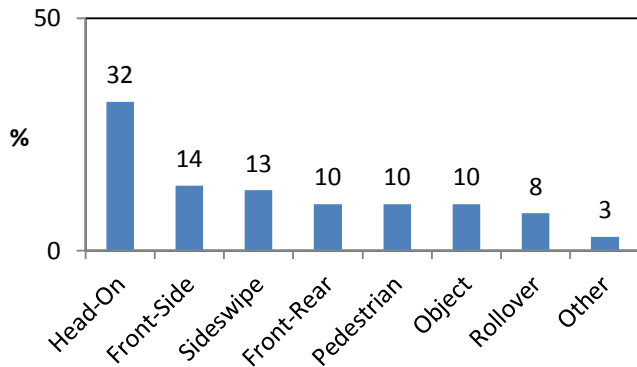
The distribution of the 167 crashes by crash configuration is as shown in [Figure 17](#) below.

Figure 17. Percentage distribution of 167 accidents by crash configuration.

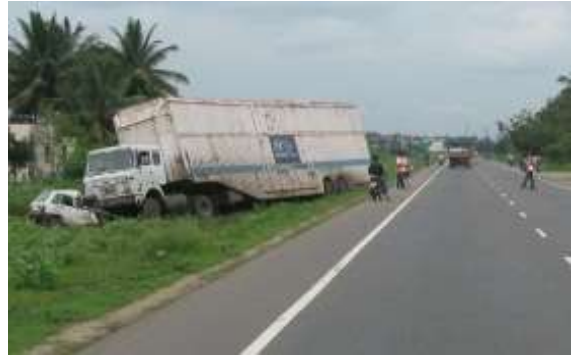
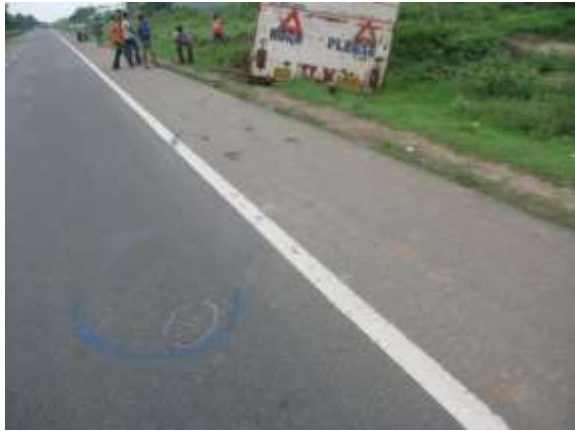
Crash Scene Pictures – The pictures from the scene of the accident are shown below in [Figure 19](#).

Figure 19. Pictures showing the final rest position of the vehicles (top) and a gouge mark indicating the point of impact (bottom).

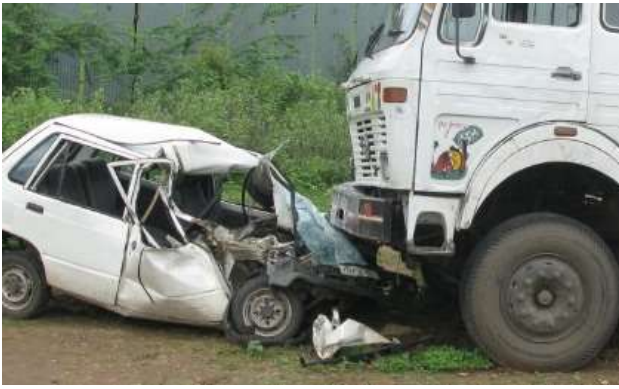
During interior examination of the car, heavy intrusions were observed and noted on the front right side of the vehicle pushing the A-pillar, the steering wheel and the roof towards the driver. The right side B-pillar and left side A-pillar also show intrusion due to impact. Hair sample and blood were seen on the windshield indicating head contact by the driver. [Figure 20](#) shows the intrusions of the car and the cause of those intrusions.

Figure 20. Intrusions of the car caused due to underride with the truck.

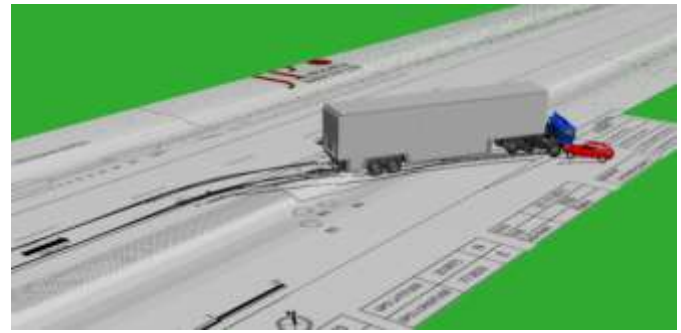
Figure 21. PC-Crash reconstruction of the accident.

Accident Reconstruction – The accident was reconstructed using PC-Crash. Figure 21 shows the simulation sequence and Table 5 shows the results.

Tata Tractor-Trailer 3516 EX	Maruti 800
Delta- V (kmph)	4	86
Collision angle (deg)	-179	179
EES (kmph)	19	69
Driving Speed (kmph)	Unknown	62
Collision Speed (kmph)	60	43

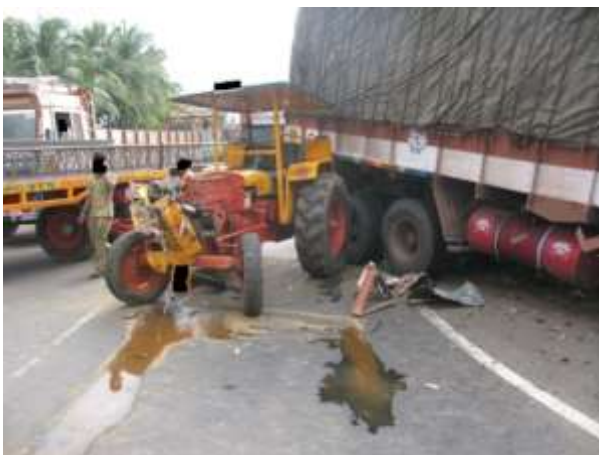
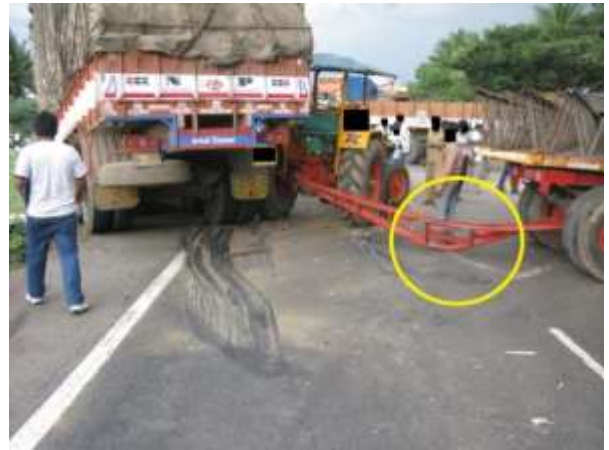
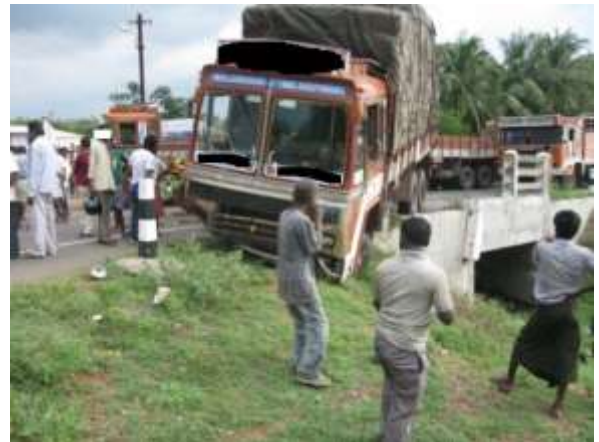
Crash Scene Pictures - The pictures from the scene of the accident are shown below in Figure 23.

Figure 23. Pictures showing the final rest position of the vehicles.

The evidences on the accident spot clearly showed that the farm tractor lost control and yawed before impacting with the haulage truck. This yawing occurred due to jackknifing effect. The truck driver braked and tried to avoid the collision by steering left, but due to very little time to react, the crash was unavoidable. The truck also had an impact with the side bridge wall before coming to rest.

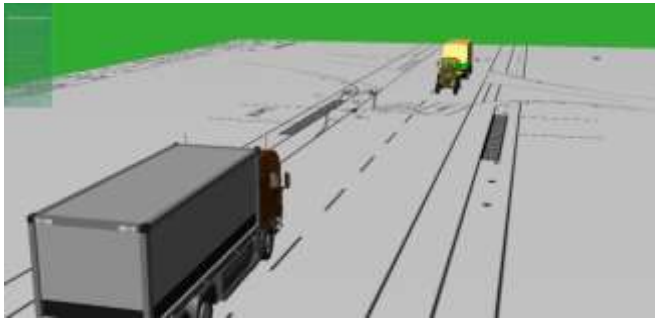
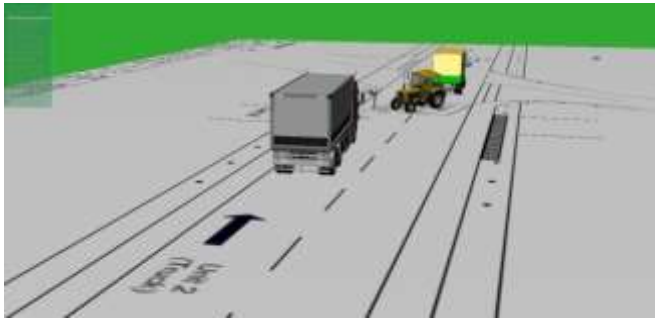
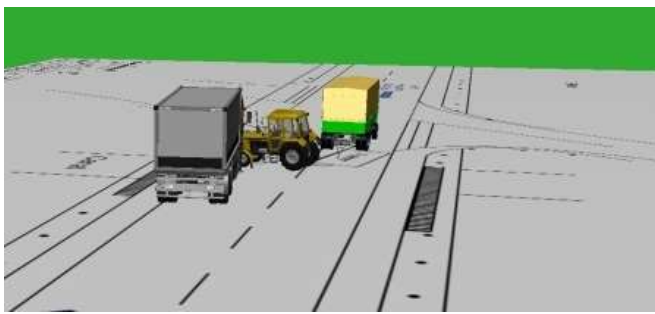
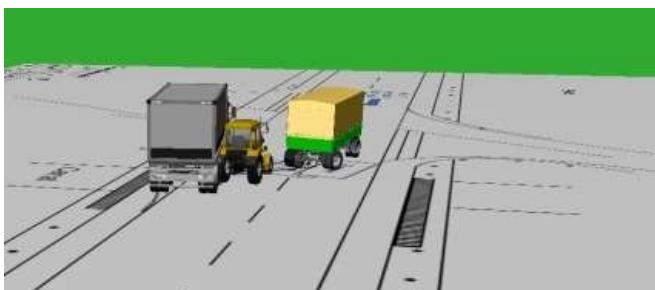
Accident Reconstruction – The accident reconstruction was done using PC-Crash and Figure 24 shows the simulation sequence and Table 8 shows the results.
